# STAFFORDVILLE RESERVOIR DAM CT. 00333

## PHASE I INSPECTION REPORT NATIONAL DAM INSPECTION PROGRAM

DECEMBER 1978

Identification Number:	CT 00333
Name:	Staffordville Reservoir Dam
Town:	Staffordville
County and State:	Tolland County, Connecticut
Stream:	Furnace Brook
Date of Inspection:	October 5, 1978

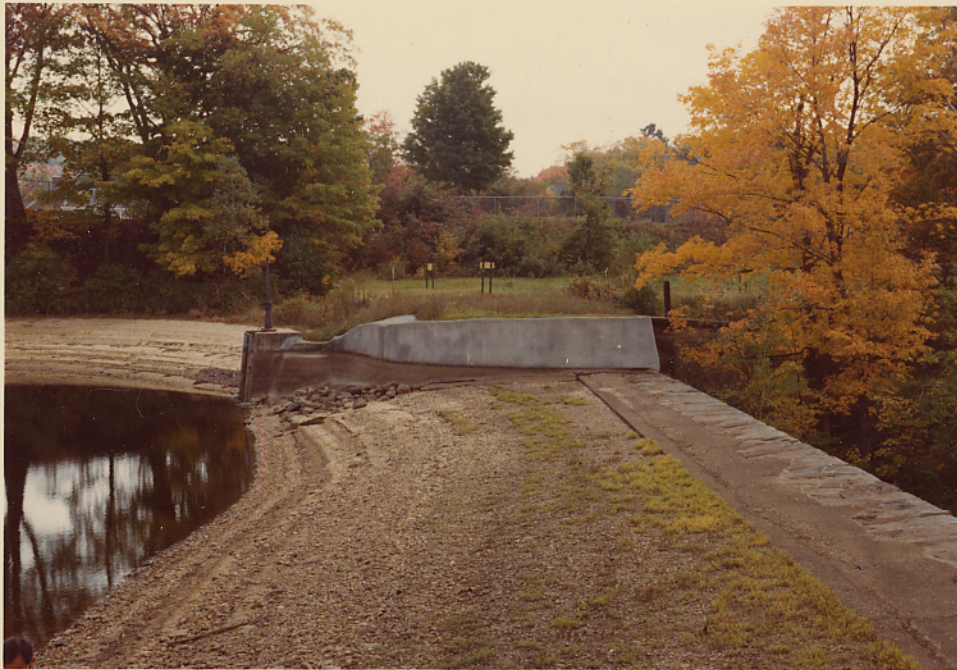
There is no underdrain system for the dam. Because the water level was down approximately five feet from the top of the spillway, the rate of seepage is fairly low. The inspection did not show signs of any movement or distress of the masonry spillway (Appendix C, Photos 1 and 2). The alignment of the dam is good and there are no signs of movement of the upstream embankment.

PHOTO 1  
CREST OF DAM LOOKING EAST

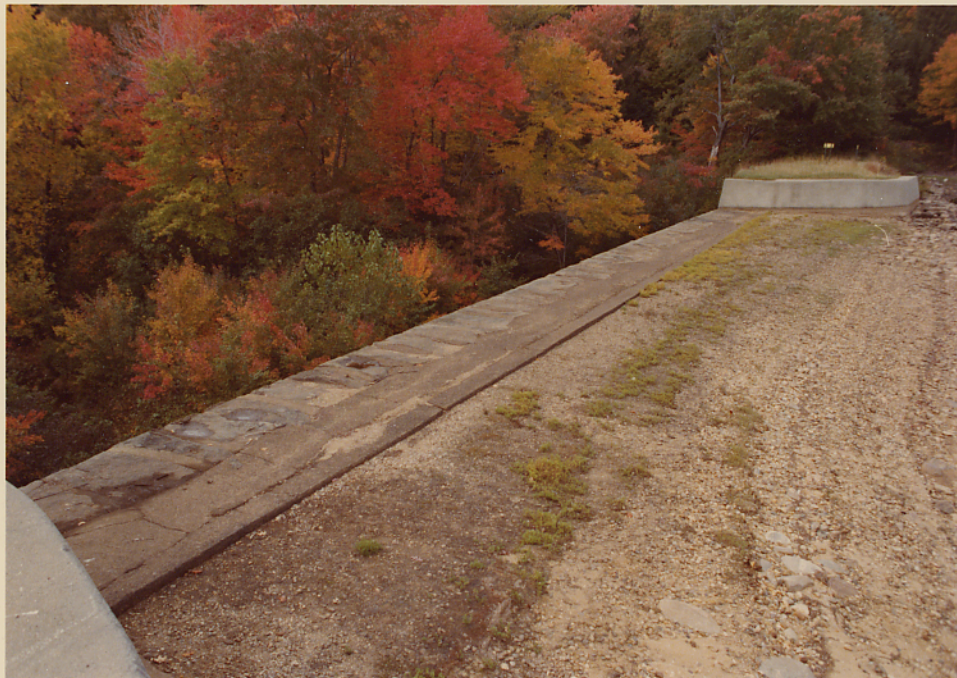
PHOTO 2  
CREST OF DAM LOOKING WEST

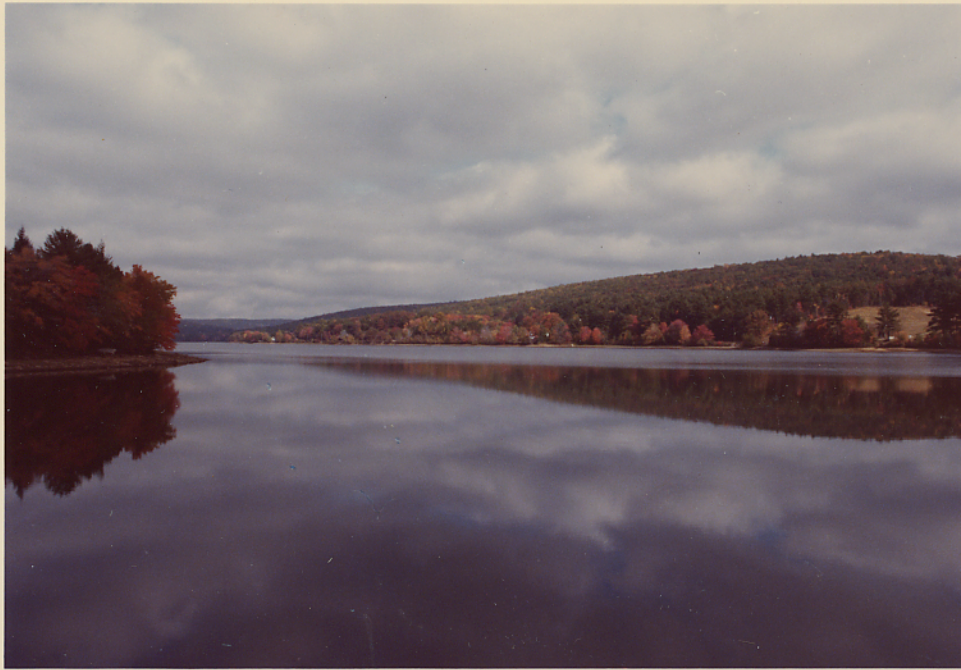
PHOTO 3  
UPSTREAM OF DAM CREST

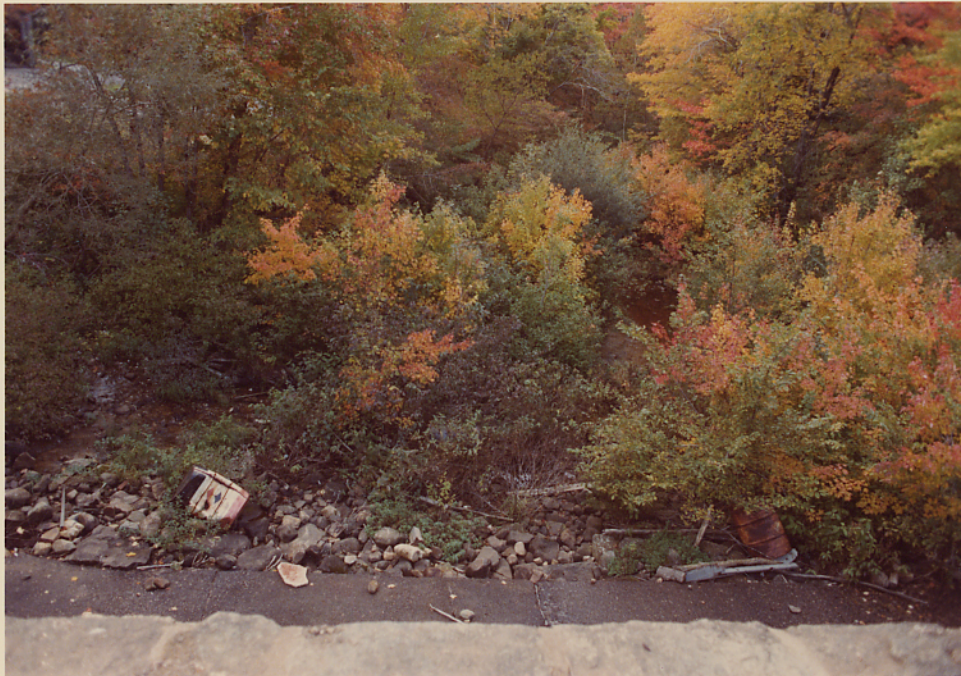
e. Downstream Channel - The spillway has a concrete apron but the downstream channel (Appendix C, Photo 4) is overgrown with trees and dense brush so that it is difficult to determine any abnormalities.

PHOTO 4  
DOWNSTREAM OF DAM CREST
